UT DIVISION OF WATER RIGHTS – DAM SAFETY SECTION

DAM INSPECTION REPORT – 2023

Dam Name / Number	Silver Leaf / UT00327		
Inspection Date	May 2, 2023	Hazard rating	High
Weather	Cloudy, Mid 60°'s	Rating is appropriate?	Yes
Reservoir Level, ft	4,998.1	SOP is current?*	Yes
Date of last outlet insp.	2017	EAP is current?*	No
Spillway Flow, cfs	None	EAP is distributed?*	No

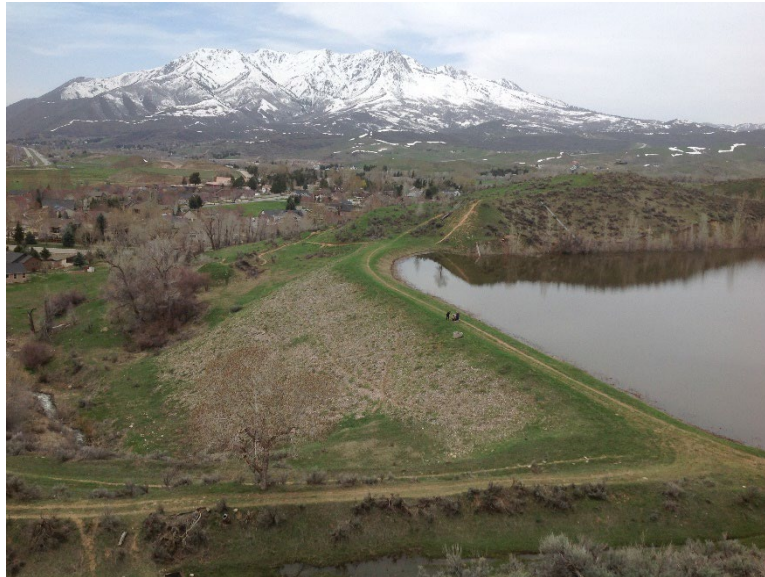
Photo #1:

Caption: General overall view of dam embankment.

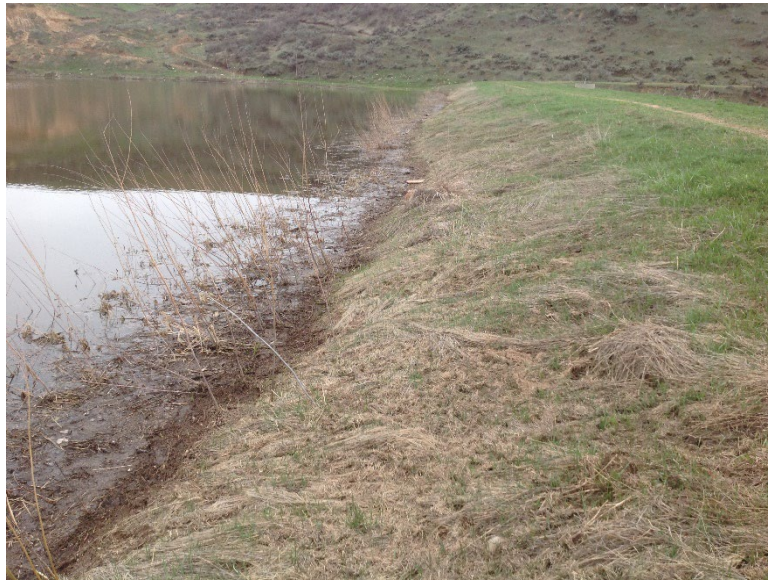
Photo #2:

Caption: Willows becoming established on the upstream slope.

Checklist Item	Necessary Action, Maintenance and/or Repair:
1, 2	Continue efforts to eradicate rodent activities from the dam embankment and completely backfill their burrows.
2, 3, 4, 6, 8	Continue efforts to remove woody vegetation from and within 25-feet of the dam embankment. Particularly on the upstream slope and in the right downstream toe and abutment groin area.
23	a) The staff gage is unreadable. Re-mark the concrete pedestal elevation plates according to the 2019 survey. b) We support plans to install a new sloping staff gage.

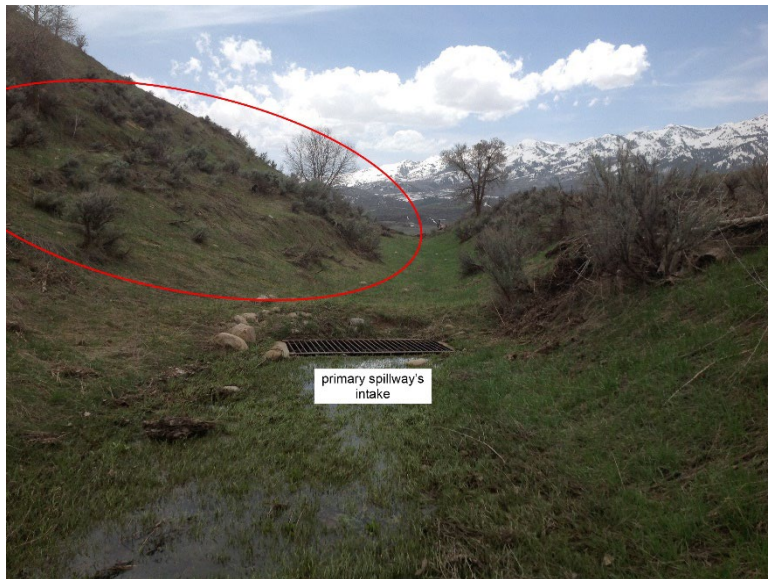
Photo #3:

Checklist Item	Comments:
9, 15	Continue to monitor the slope instability along the reservoir’s west rim and the landside located above and to the east of the emergency spillway discharge channel. The landside above the emergency spillway channel appears to be the same since 2005 with no signs of active movement.
15	Fill material continues to exist within the downstream portion of the emergency spillway discharge channel. To prevent the overall spillway capacity from becoming compromised, the top of this infill material is to be maintained at an elevation that is below the elevation of the primary spillway’s intake. In 2021, the downstream property owner agreed to place a properly sized culvert through the area in question. To date, no culvert has been installed.
15, 19	We recommend that spillway and outlet conduits be internally inspected once every 5 years.
EAP	Update the contact information found in the Emergency Action Plan (EAP) and distribute a copy to our office and other plan holders.

Caption: Historic landslide in the emergency spillway discharge channel.

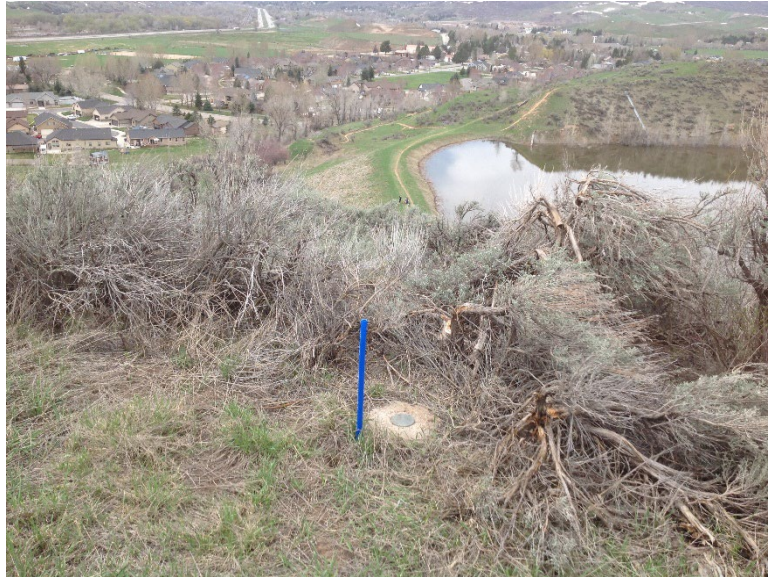
Photo #4:

Caption: Left (east) abutment benchmark (BM #2).

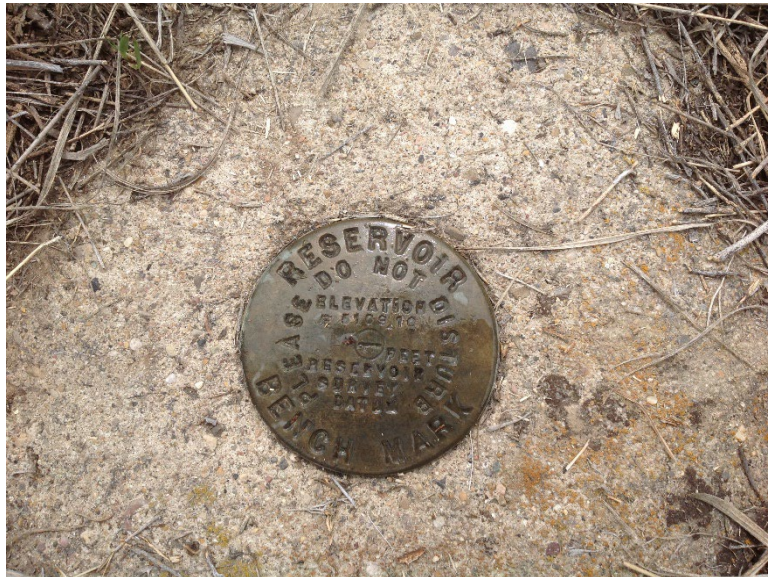
Photo #5:

Caption: Close-up view of left (east) abutment benchmark (BM #2).
